Durability of bonded FRP-to-steel joints: Effects of moisture, de-icing salt solution, temperature and FRP type

Mohsen Heshmati^{*}, Reza Haghani, Mohammad Al-Emrani

Dept. of Civil and Environmental Engineering, Division of Structural Engineering, Chalmers University of Technology, Gothenburg, Sweden

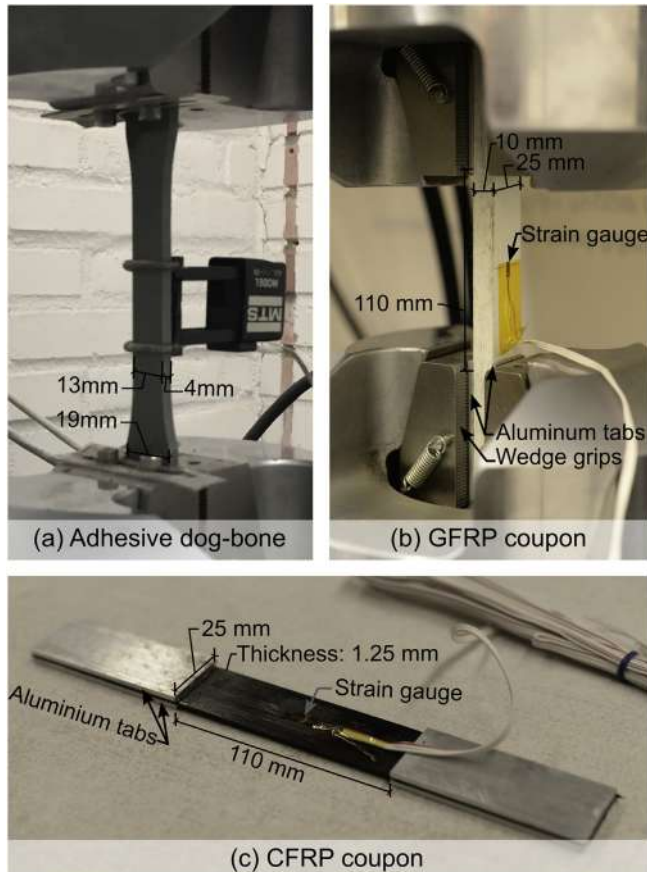
Fig. 1. Configurations of material-level tests.

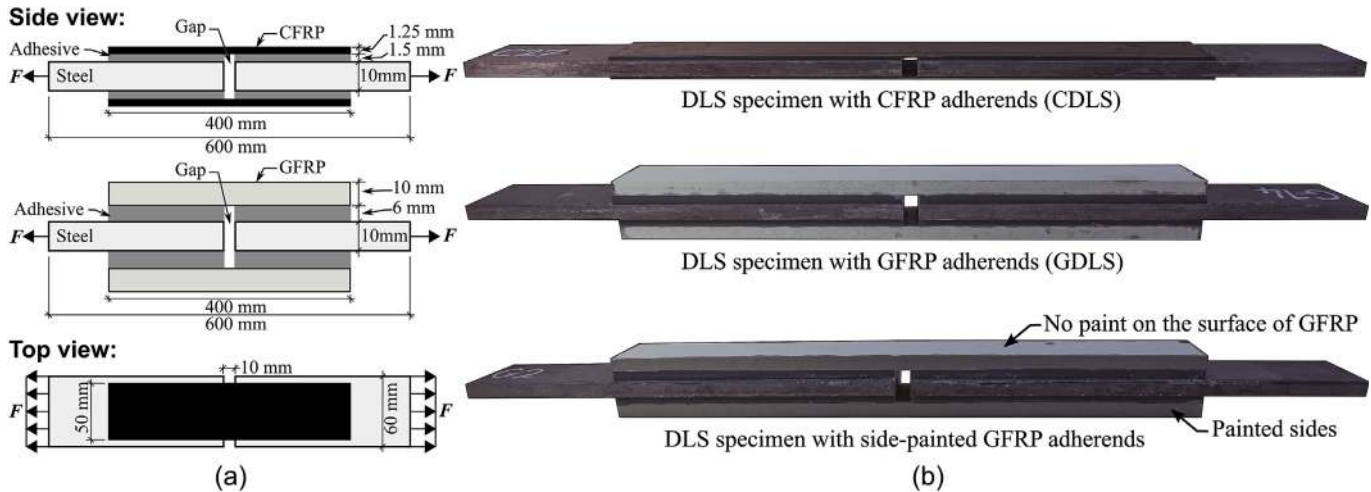
Fig. 2. (a) Schematics of double-lap shear joints, (b) photographs of manufactured specimens.

Fig. 2 depicts the schematics and photographs of the manufactured joint-level specimens. A total of 44 CFRP/steel and 40 GFRP/steel double-lap shear (DLS) specimens were manufactured. As the free edges of GFRP plates in practice are not always a wet boundary condition (e.g. GFRP deck panels on steel girders), the edges of GFRP laminates were painted on six GFRP/steel specimens, see Fig. 2(b), in order to simulate an impermeable boundary condition. To prevent moisture diffusion from those faces, two layers of a water-resistant paint (JOTUN[®] Jotamastic 87) were applied. For each specimen type, three were tested before ageing and the rest after ageing for up to 1080 days (three years). The FRP laminates were chosen to be narrower than the steel plates to represent a typical field application in bridges where the entire flange may not be covered by FRP. The adhesive layer thickness was also designed to comply with different applications of FRPs in bridges where a thickness of 1–2 mm is often found in strengthening applications and 4–10 mm in GFRP-deck/girder connections. In order to ensure the uniform thickness of the adhesive layer and precise end detailing, i.e. without adhesive fillets at the ends, special moulding forms were used. Details of the fabrication process are given in Ref. [33]. Tests were carried out using a universal testing machine with a capacity of 250 kN at a constant displacement rate of 0.1 mm/min. The axial displacement of the specimen, as well as its transverse displacement at the gap location, was recorded using a series of LVDT transducers. In addition, a high-resolution digital camera was used to monitor damage evolution during testing.

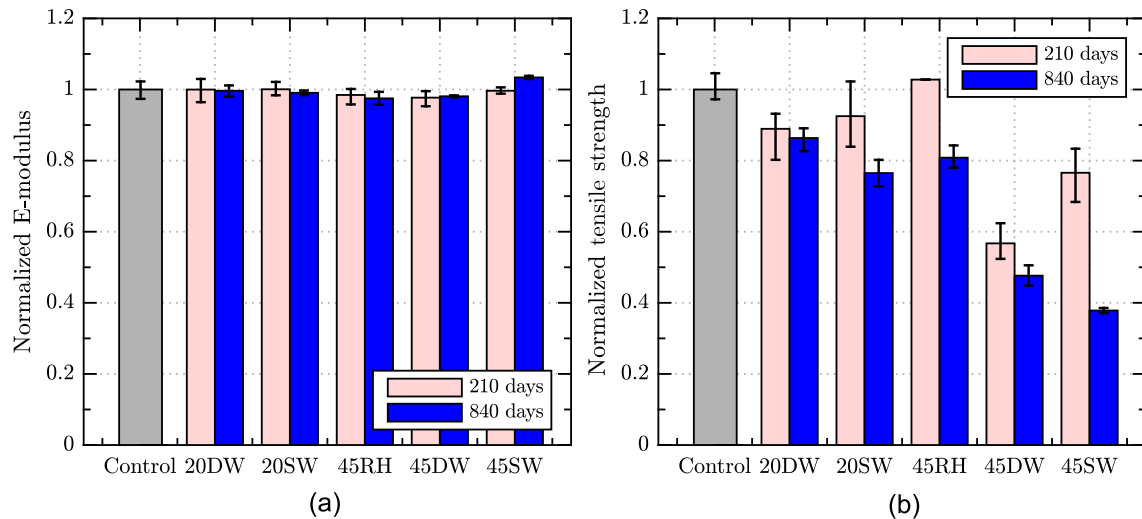
Fig. 3. Effect of ageing on the normalized mechanical properties of CFRP: (a) E-modulus, (b) tensile strength.

materials. The low permeability of the used CFRP material could be attributed to its high fibre content, resin type and manufacturing quality. Fig. 3 shows the effect of various ageing scenarios on the E-modulus and tensile strength of CFRP. For each ageing condition, tests were performed after exposure for 210 and 840 days (seven and 28 months respectively). The error bars show the scatter range of three replicas tested in each group. As is apparent from Fig. 3(a), the modulus of elasticity is hardly affected by any of the ageing conditions, even after 840 days of exposure. Given the fibre dependence of the E-modulus of unidirectional composites, as well as the stability of carbon fibres in the presence of moisture [11], this observation can be justified.

The tensile strength, on the other hand, was significantly degraded with increased exposure duration and the severity of the ageing condition, see Fig. 3(b). This observation can be explained by the change in failure mode observed during tests, see Fig. 4. With increased exposure, the failure shifted from a rupture mode to the interlaminar failure of CFRP at the grips. Interlaminar shear strength is a resin-dominated property that is highly susceptible to environmental degradation. Although the tensile coupon test is not an appropriate configuration for the quantitative assessment of interlaminar shear strength, it is possible to evaluate the degradation trends qualitatively, as all the tested CFRP coupons were subjected to the same pressure at the grips. In this regard, at a given temperature, the short-term immersion in distilled water is found to be more damaging than salt water. This is believed to be due to the moisture-diffusion characteristics that would result in a higher near-surface moisture concentration of the specimens immersed in distilled water compared with salt water at the same temperature (see Table 2). Consequently, the rate of accumulation of salt water molecules at resin/fibre interface close to the surfaces of CFRP

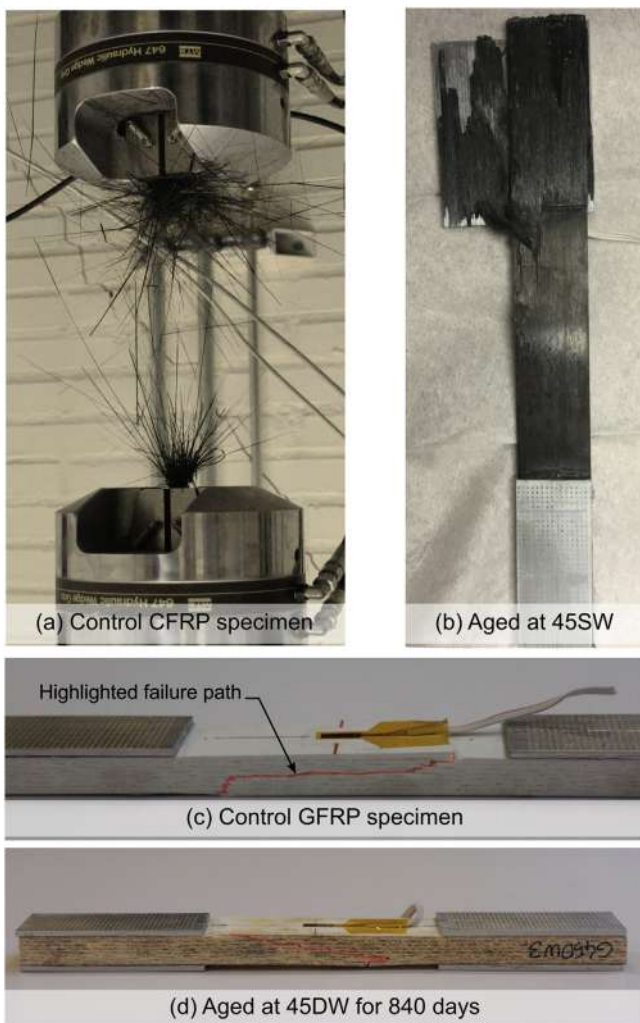
Fig. 4. The change in failure mode of CFRP coupon tests after environmental ageing.

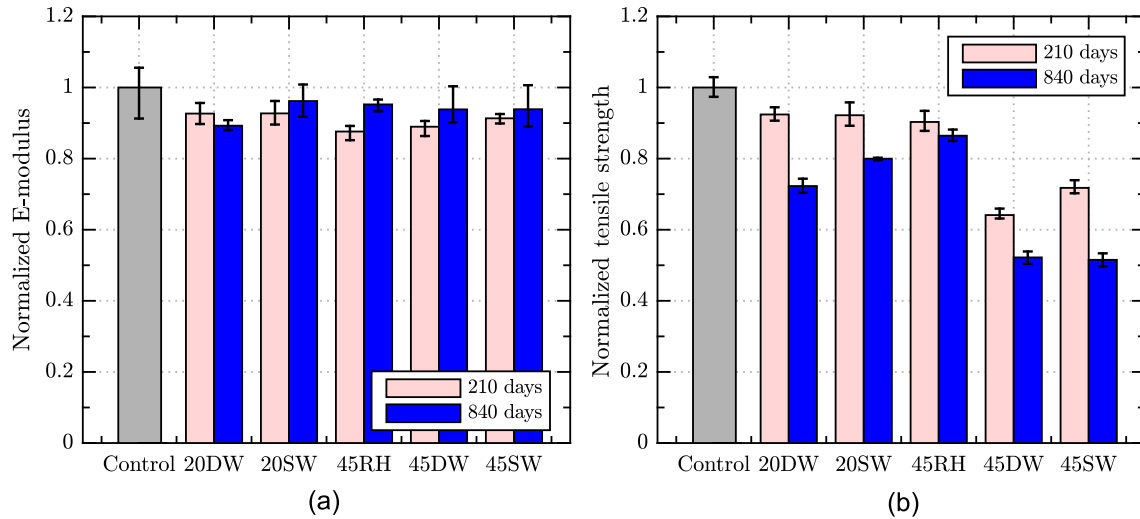
Fig. 5. Effect of ageing on the normalized mechanical properties of GFRP: (a) E-modulus, (b) tensile strength.

The GFRP material is extremely permeable, with the fastest diffusion rates among those listed in Table 2. In fact, all the GFRP coupons would reach moisture saturation less than a month after exposure [14]. The effect of ageing on the normalized E-modulus and tensile strength of GFRP coupons is plotted in Fig. 5. It is noticeable that, similar to CFRP coupons, ageing has significantly affected the strength, whereas the average degradation of the E-modulus is generally less than 10%. All the tested GFRP coupons exhibited a similar failure mode, as shown in Fig. 4(c) and (d). As can be seen, tensile strength is governed by a combination of fibre and resin failure. In addition to the common susceptibility of resins to ageing, glass fibres (unlike carbon fibres) may also degrade in the presence of moisture with prolonged exposure. As a result, while the initial reduction in strength is believed to be a consequence of degrading resin and fibre/resin interface [35], its further reduction after 840 days can also be attributed to damaged glass fibres [36].

joints is plotted in Fig. 17. As can be seen, the reductions in the initial joint stiffness in GFRP/steel specimens are noticeably larger than that of CFRP/steel specimens. There are two main arguments that can be put forward to explain this observation. Firstly, the data presented in Fig. 5(a) appear to suggest that the modulus of elasticity of GFRP is more susceptible to degradation compared with CFRP, cf. Fig. 3(a). Secondly, considerably faster moisture diffusion into the adhesive layer of GFRP/steel specimens decreases its overall stiffness and thus leads to a further reduction in joint stiffness. A closer look at the data indicates that, while ageing at 20SW for up to three years caused no significant variation (approx. 4%) in the initial stiffness of CFRP/steel joints, the GFRP/steel specimens underwent an approximately 20% reduction after only one year of ageing.

Fig. 19(a) reveals that the strength of GFRP/steel DLS joints, in general, declines sharply after immersion. As discussed earlier, the residual strength of these joints should be proportional to the strength reduction of the GFRP material. A closer look at Fig. 5(b) indicates that immersion at 45 °C led to a greater strength reduction than that at 20 °C. This outcome is in line with the bond strength results for GFRP/steel DLS joints, which demonstrate

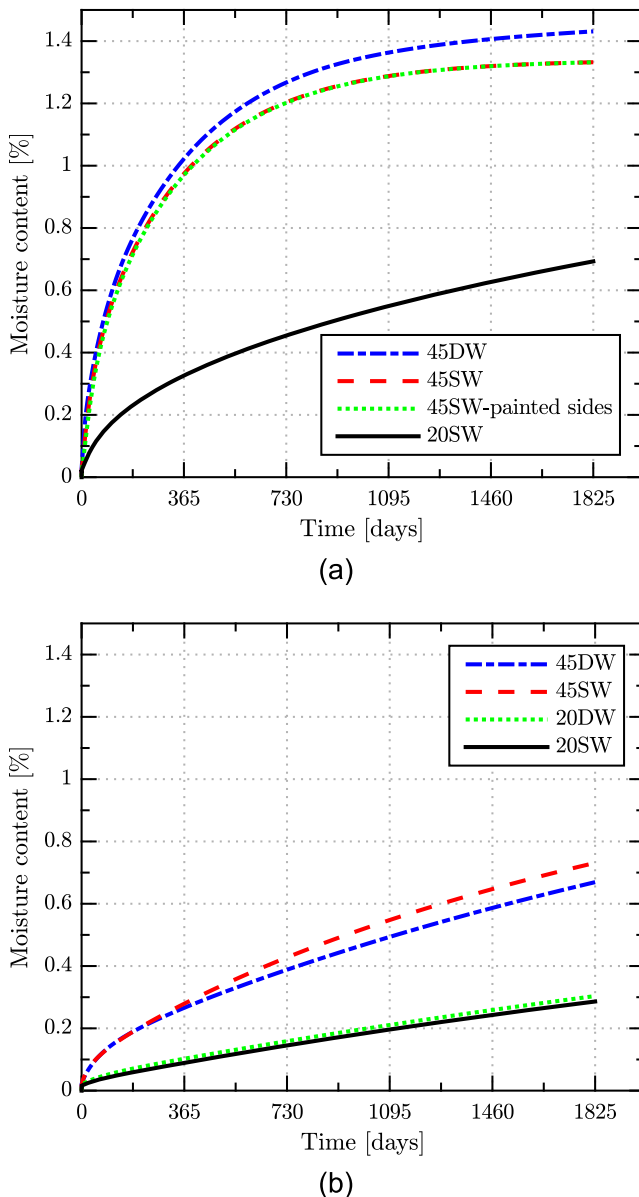
Fig. 7. Predicted total moisture content of the adhesive layer in DLS specimens: (a) GFRP/steel, (b) CFRP/steel.

The predicted moisture content summed over the volume of adhesive layer in DLS specimens is plotted in Fig. 7. As can be seen,

the absorbed moisture at the same temperature and time is significantly higher in GFRP/steel specimens compared with CFRP/steel specimens. This observation could be explained by the high permeability of the GFRP material compared with the almost impermeable CFRP laminates, which provides an additional boundary condition for moisture uptake. This permeability can be attributed to the structure of the two composite materials and the types of fibre and matrix used to manufacture them. Shortly after exposure (approximately two to four weeks, depending on the exposure condition), GFRP becomes saturated and provides new and considerably shortened moisture diffusion routes through the thickness of the adhesive layer.

Another observation from Fig. 7(b) is that, after almost one year, the moisture content of the adhesive layer in CFRP/steel specimens aged in 45SW exceeds that of the ones aged in 45DW. This observation can be explained in the light of the predicted moisture profiles in CFRP/steel joints illustrated in Fig. 9. Since the saturation moisture content and diffusion rates of the adhesive are higher than those of the CFRP in all environments (see Table 2), a portion of the diffused moisture in the adhesive will be transported into the adjacent CFRP material. This, in turn, would result in a loss of moisture content in the adhesive layer. This process occurs to the greatest degree in the 45DW condition due to the highest associated moisture saturation level of the CFRP material.

one year of immersion in distilled water and salt water respectively. Given the relatively slow moisture diffusion into adhesive at 20 °C, see Fig. 7(b), and, as the failure mode of these specimens remained cohesive, this behaviour can be associated with the full-cure of adhesive. This beneficial effect appears to disappear with higher diffused moisture after immersion in salt water for three years. In spite of this, the results suggest no degradation of failure load after such a long exposure period. It is noteworthy that the relatively large scatter of results obtained for the 20DW series is due to a different failure mode in one of the tested specimens, which is presumed to be due to material or specimen manufacturing defects.

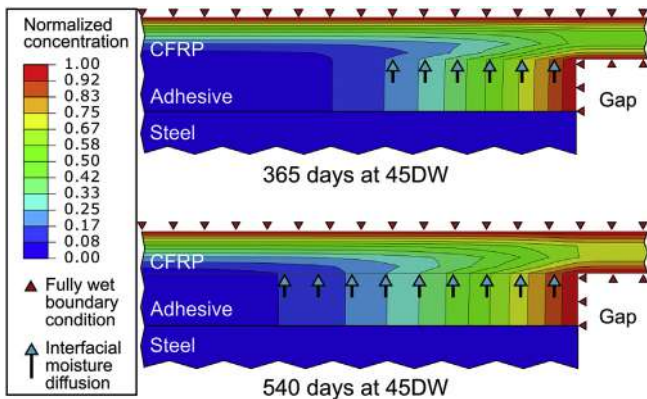
Fig. 9. Contour plots of through-thickness moisture distribution close to the gap of CFRP/steel specimens along the centre line of the joint.

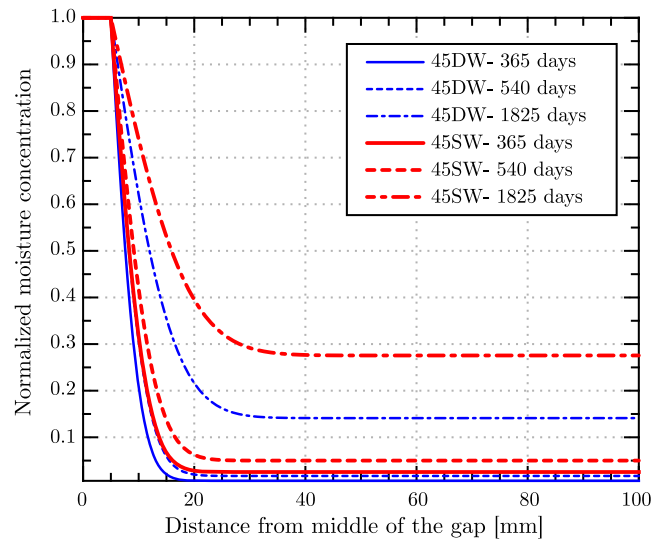
Fig. 10. Moisture concentration of the CFRP at the CFRP/adhesive interface along a path located at the mid-width of the joint.

Fig. 10 shows a comparison of the normalized moisture concentration of CFRP along its interface with the adhesive at various exposure durations in 45DW and 45SW. As can be seen, at similar exposure durations and temperature, the normalized moisture concentration is higher in salt water than in distilled water. This observation can be also attributed to the interfacial moisture transport from the adhesive to the CFRP material. In this regard, the moisture available at the interface of CFRP and adhesive is limited by the diffusion rate of the adhesive material, which is merely a function of temperature [14]. Moreover, given the higher moisture saturation content of CFRP in 45DW compared with 45SW, a larger amount of moisture is required in 45DW for an equal increase in normalized moisture concentration. For this reason, at the same exposure temperature and time, the normalized moisture saturation would be higher for the condition that gives a lower moisture saturation content for CFRP, i.e. 45SW. Given the large degradation of the interlaminar shear strength of CFRP upon ageing, its moisture concentration at the interface with adhesive is expected strongly to affect the strength of the bonded joints (Section 4.3.3).

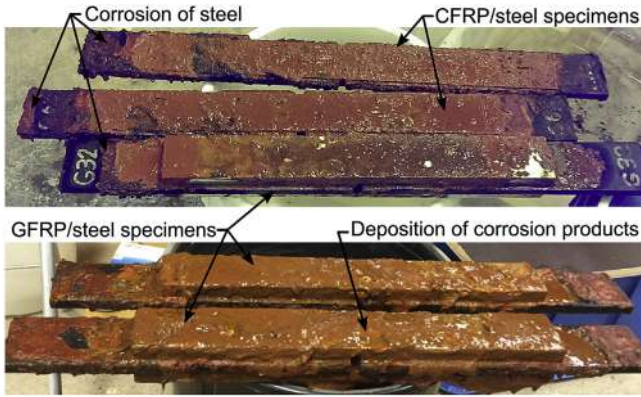
Fig. 11. DLS specimens after environmental ageing.

Fig. 11 shows images of DLS specimens directly after removal from the conditioning tanks. It is apparent that the steel plates were significantly corroded. Visual inspections revealed that the corrosion was more severe at 45 °C compared with 20 °C after similar ageing durations. The deposition of corrosion products on the surfaces of FRP adherends led to the slight discoloration of both CFRP and GFRP materials. However, no signs of wear or the debonding of FRP laminates were observed during the inspections. It was only in the case of prolonged exposure, i.e. after one year, of GFRP/steel specimens that cracks were visually detected in the

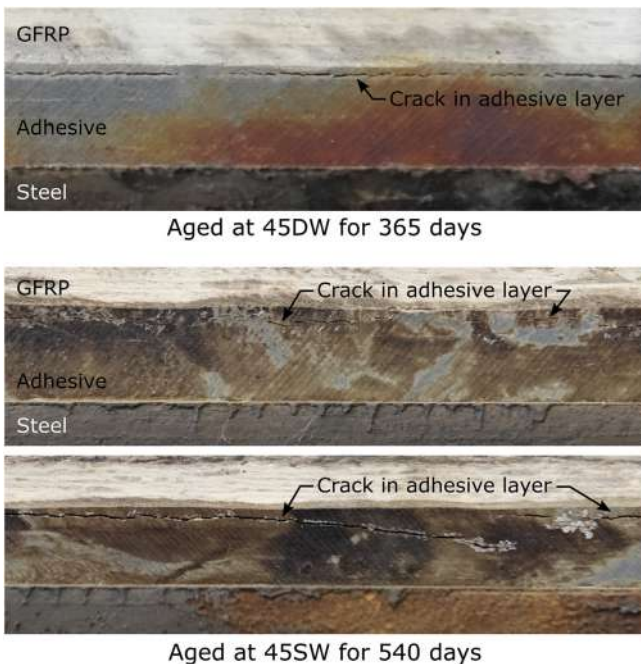
Fig. 12. Cracks that appeared in the adhesive layer of GFRP/steel specimens upon prolonged ageing.

adhesive layer, see Fig. 12. As can be seen, these cracks were directed longitudinally and located very close to the GFRP laminates. The cracks were also accompanied by the dispersed discoloration of the adhesive material. The formation of these cracks in the GFRP/steel series was limited to the specimens aged for more than 180 days in 45DW and 540 days in 45SW. One explanation of this phenomenon could be the non-uniform moisture distribution in the adhesive layer in GFRP/steel specimens, as discussed in Section 4.2. Given that moisture uptake is able to induce volumetric expansion (i.e. swelling), the swelling of the wet portion of the

degradation of around $34 \pm 5\%$ and $26 \pm 4\%$ respectively after one year. The relatively greater drop in stiffness for the 45DW series stems from the higher saturation moisture content of the adhesive in this condition. It is also interesting to note that, up to one year of exposure, specimens with or without painted GFRP edges perform similarly. The stiffness of specimens aged in 45DW remained constant by extending the exposure to 18 months, whereas it dropped sharply for those aged in 45SW. The most likely cause of this observation is that the cracks that appeared in the adhesive layer of GFRP/steel specimens were the most severe for those aged in 45SW for 18 months (see Fig. 12).

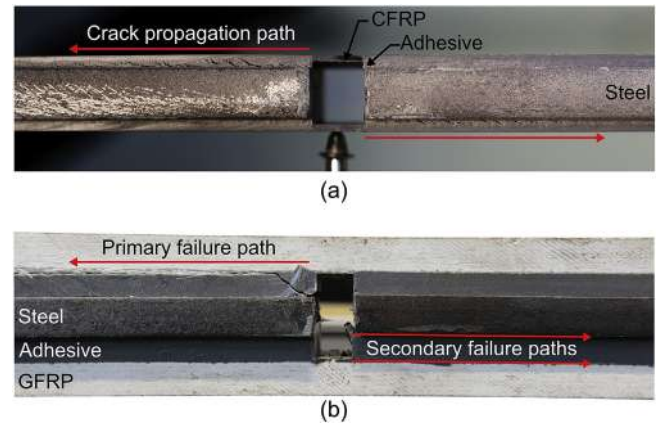
Fig. 13. Failure mechanism of control DLS specimens during residual strength tests: (a) CFRP/steel, (b) GFRP/steel specimen.

The failure mechanism of CFRP/steel control specimens is depicted in Fig. 13(a). As can be seen, two dominant cracks were initiated on the opposite sides of the gap in a diagonal pattern. Post-fracture analysis of the failure surfaces revealed that all the control CFRP/steel specimens exhibited cohesive failure as the triggering failure mode, see Fig. 14(a). This observation confirms good bond quality which ensures high joint efficiency and ductility. Cohesive failure was also the triggering failure mode of all the specimens aged at 20 °C, except for one which failed due to CFRP delamination. However, the cohesive failure mode changed to a number of other failure modes upon ageing at 45 °C, as illustrated in Fig. 14(b–e). In particular, ageing in 45SW caused the fastest change in failure mode to combined interfacial/interlaminar CFRP failure after only 120 days of exposure, see Fig. 14(b). After 240 days of exposure, this failure mode changed to the interlaminar failure of CFRP at its interface with the adhesive, see Fig. 14(e). In comparison, the failure mode of CFRP/steel specimens aged for 540 days in 45DW remained as interfacial/cohesive. The failure of joints in 45SW due to the interlaminar failure of CFRP further confirms the importance of the normalized moisture concentration of CFRP that was discussed in Section 4.2 (see also Fig. 10). It should be mentioned that, despite the visible corrosion of exposed steel parts, no corrosion of steel in the bonded areas was detected by visual inspection after testing.

As is apparent from Fig. 13(b), the behaviour of control GFRP/steel specimens was governed by a combination of failure mechanisms. The primary failure was mainly composed of the delamination of the GFRP at the 0° ± 90° mat layer and finishing layer, see Fig. 15(a). This was accompanied by a sharp drop in load during the tests. After this point, the load was transferred through only one of the laminates. This asymmetrical load transfer led to the out-of-plane bending of the specimen (i.e. increased transverse deformation) that caused secondary failure. As a result, the reported failure modes are only based on the primary failure location, as it is representative of the joint in-service behaviour. In this regard, immersion in 20 °C salt water (20SW) for up to one year did not cause any changes in the failure mode compared with control specimens, see Fig. 15(b). The failure mode of GFRP/steel specimens immersed in 45 °C salt water (45SW) for up to one year was similarly caused by the interlaminar-shear failure of the GFRP laminate. However, increasing the exposure duration to 540 days shifted the primary failure location to the adhesive layer close to GFRP, i.e. cohesive failure, Fig. 15(c). Painting the edges of the GFRPs did not cause any further change in this behaviour. Nevertheless, ageing in 45DW accelerated this process; the interlaminar failure

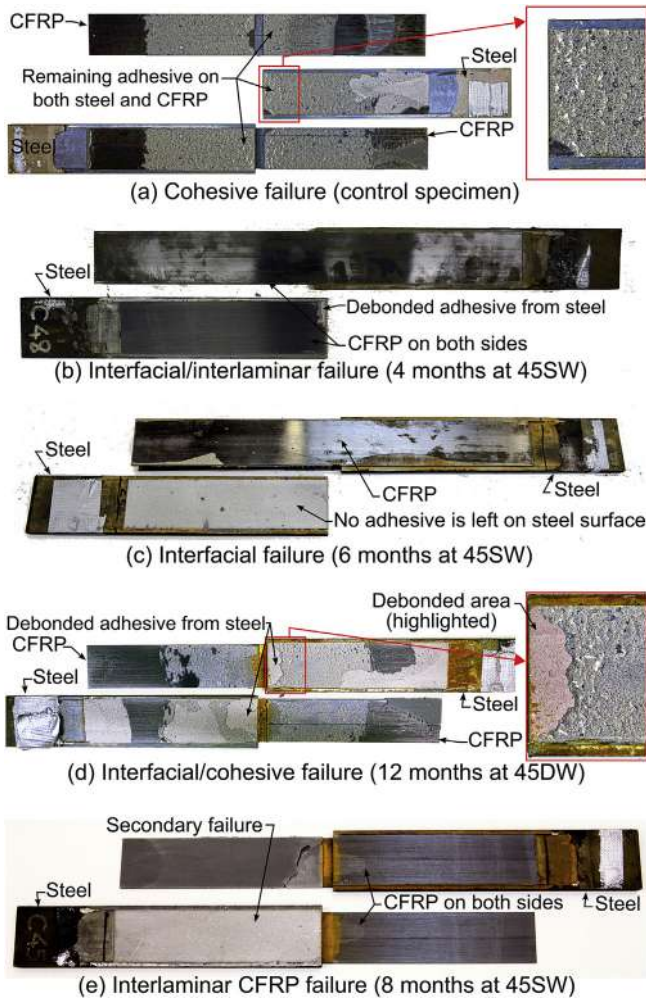
Fig. 14. Examples of fracture surfaces and failure modes of CFRP/steel specimens.

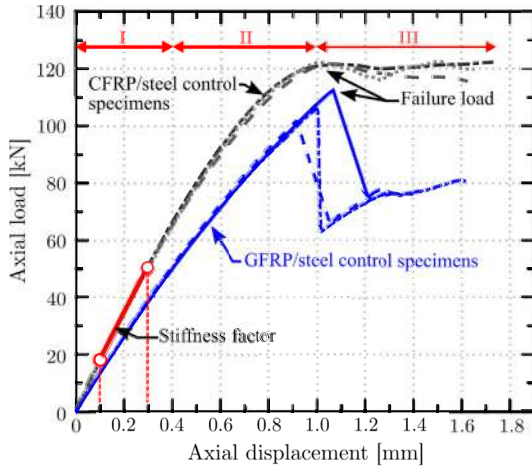
Fig. 16. Definition of stiffness factor and failure load for DLS specimens.

The stiffness of DLS joints is evaluated by studying the relationship between axial load and axial displacement. Fig. 16 shows this relationship for control DLS specimens. As can be seen, the load increases almost linearly in zone I, non-linearly in zone II, at the end of which a maximum load is reached, and remains almost constant afterwards (zone III). It is shown by the authors in Ref. [42] that, from a damage point of view, zone I is the state of no damage, zone II is the damage development state and zone III corresponds to crack propagation. So, to evaluate the stiffness of DLS joints prior to any damage, a stiffness factor is defined as the slope of the load-displacement curve calculated using two points within zone I. For the sake of consistency, these points were taken at axial displacements corresponding to 0.1 and 0.3 mm for all specimens. Moreover, In order to define a consistent failure criterion for the tested joints, the changes in joint stiffness during testing are further evaluated by differentiating the load-displacement curves. In this regard, the load at the point where it drops suddenly or stiffness becomes zero for the first time (horizontal tangent line) is taken as the ultimate failure load and is subsequently used to assess the bond strength.

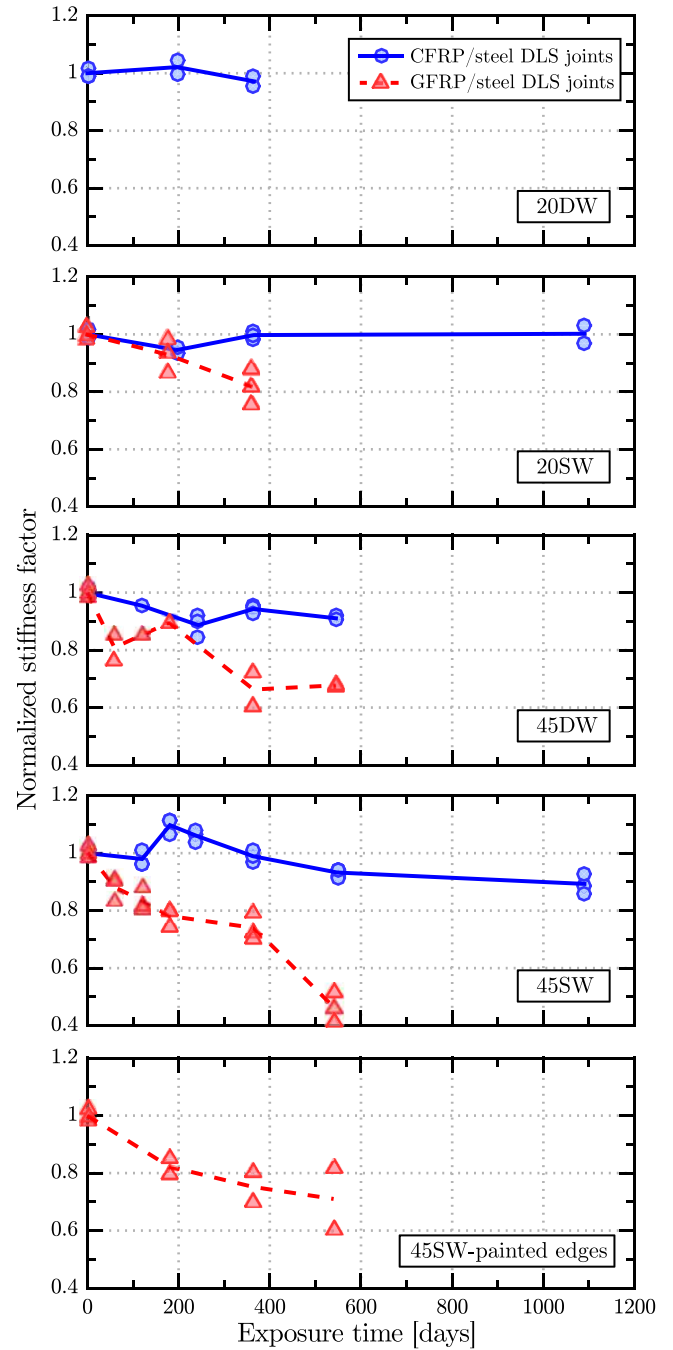
Fig. 17. Effect of environmental ageing on the stiffness of DLS joints.

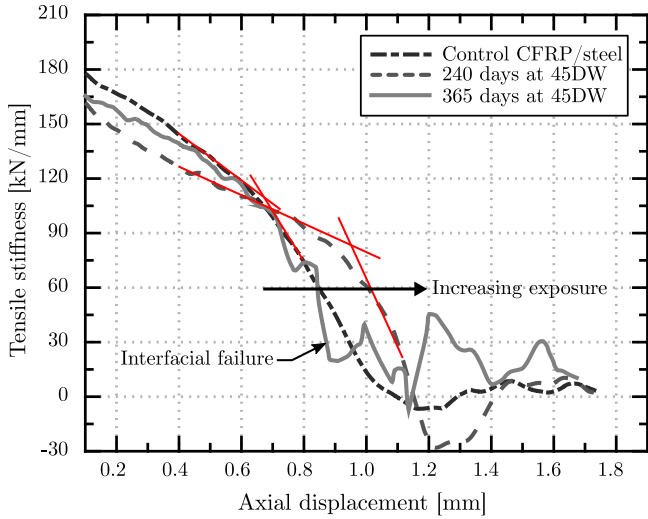
Fig. 18. Stiffness-displacement curves of CFRP/steel specimens conditioned in 45DW.

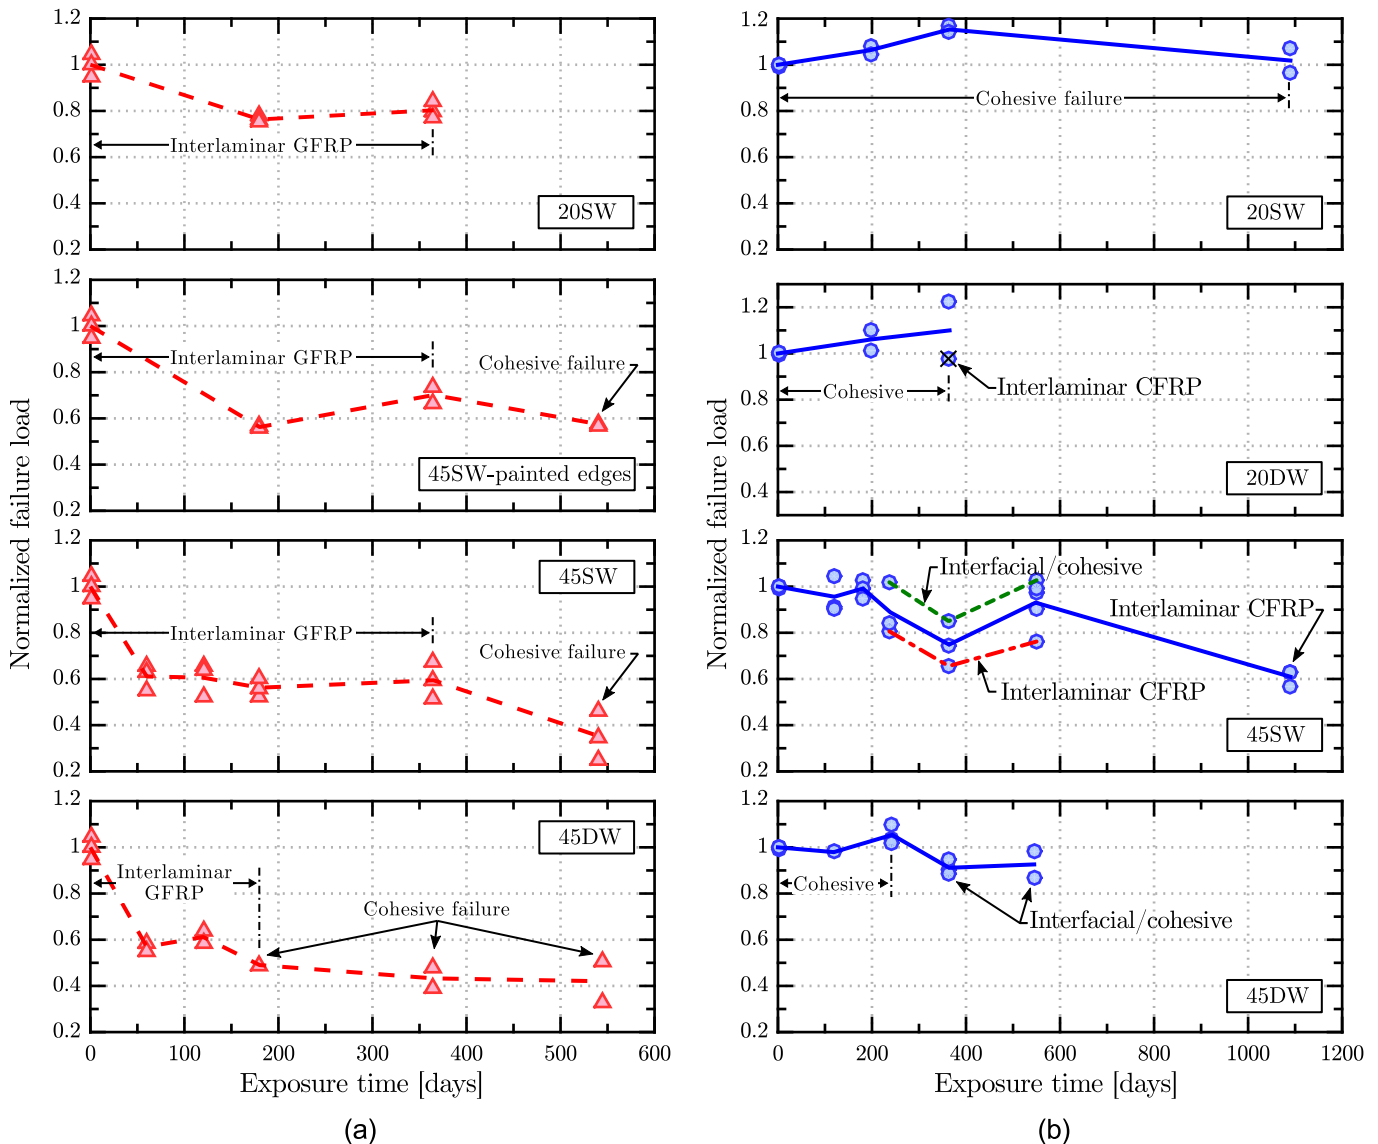
Fig. 19. Effect of environmental ageing and failure mode on the bond strength of DLS joints: (a) GFRP/steel, (b) CFRP/steel.

The effect of ageing on the failure load of DLS specimens is plotted in Fig. 19. A comparison of the average failure load for the GFRP/steel and CFRP/steel specimens suggests notably larger degradation in the former series. To address the underlying reason, the failure modes of these two series need to be analysed. As discussed before, many of the GFRP/steel specimens, including the control ones, failed due to the interlaminar shear failure of GFRP. Having noted that the bonded GFRP laminates were able to reach moisture saturation after only a few weeks of exposure, the failure load of the aged GFRP/steel specimens was governed by the strength of fully saturated GFRP material. As a result, the normalized strength degradation of the GFRP/steel series is proportional to

The effects of environmental ageing on the strength of CFRP/steel DLS joints is plotted in Fig. 19(b). This figure indicates that, for both distilled water and salt water, ageing at 20 °C for one year led to a continuous increase in failure load. In this regard, the ultimate failure load is found to increase by a maximum of 22% and 17% after

When it comes to the strength of CFRP/steel DLS joints conditioned at 45 °C, it is apparent from Fig. 19(b) that, despite a slight increase in failure load during the first few months, it declines afterwards. This behaviour is more noticeable for joints immersed in salt water that exhibit a maximum reduction of 35% and 43% in failure load after one year and three years of exposure respectively. In comparison, the highest reduction in the failure load of the joints immersed in distilled water was found to be only 13% after ageing for 18 months. The underlying mechanisms of strength degradation in a higher temperature regimen can be further investigated by studying the triggering failure modes of CFRP/steel DLS joints, see Fig. 19. As can be seen, the failure mode of specimens immersed in distilled water for eight months remained cohesive. The strength was thus slightly increased due to the plasticisation effect (Fig. 18). However, after one year, the failure mode had partly shifted to the adhesive/steel interface, which caused a slight strength degradation. In comparison, the strength of specimens immersed in salt water for eight months was governed by the interlaminar shear strength of CFRP, which led to a notably larger reduction in failure load. As can be expected, the moisture content of CFRP at its interface with the adhesive rises with increasing exposure duration. Given the data plotted in Fig. 3(b), this implies that the degradation of the strength of CFRP at this critical interface would increase with longer exposure. As was discussed in Section 4.2, the rate of this process is slower for immersion in distilled water. Having shown that the strength degradation of the CFRP material is high for immersion at 45 °C in both distilled water and salt water, the joints aged in 45DW are also expected to experience a similar degradation trend. However, this was not witnessed in this study, due to the limited exposure period.

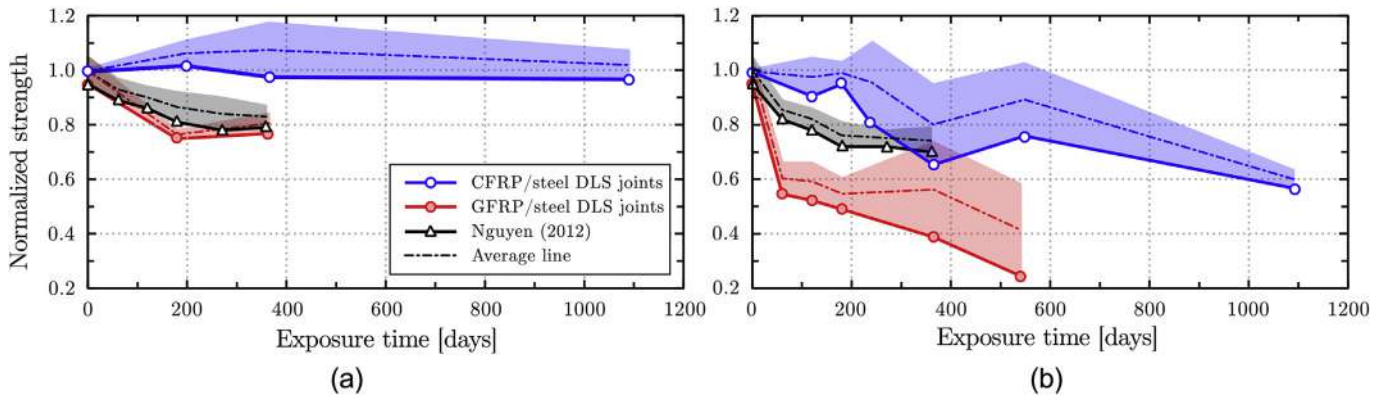
Fig. 20. Comparison of immersion conditions at different temperatures on the strength of DLS joints: (a) 20 °C, (b) elevated service temperatures (45–50 °C).

Fig. 20 illustrates a comparison of strength variations for the tested DLS joints in this study and those in Ref. [47]. The lower bound, average and scatter range of the results are plotted using thick solid lines, dashed lines and colour highlights respectively. The results are compared separately according to the immersion temperature. As can be seen in Fig. 20(a), the DLS specimens with GFRP and wet lay-up CFRP adherends exhibit very similar behaviour upon immersion at room temperature. Given that both series failed due to FRP delamination, the degradation of strength can be attributed to fibre/matrix damage. Along similar lines, Roy et al. [38] reported the degradation of the mat layer of GFRP as an important damaging mechanism in the tested steel/polyester-GFRP joints. In comparison, the low permeability of pultruded CFRPs and the cohesive failure mode led to almost no degradation of the CFRP/steel DLS joints.
